# *SCAPS Laser Induced Fluorescence Investigation*

RPM Meeting  
Naval Air Station Fallon  
April 26, 2007

Tim Shields  
Richard Brady & Associates

# *Purpose of SCAPS Investigation*

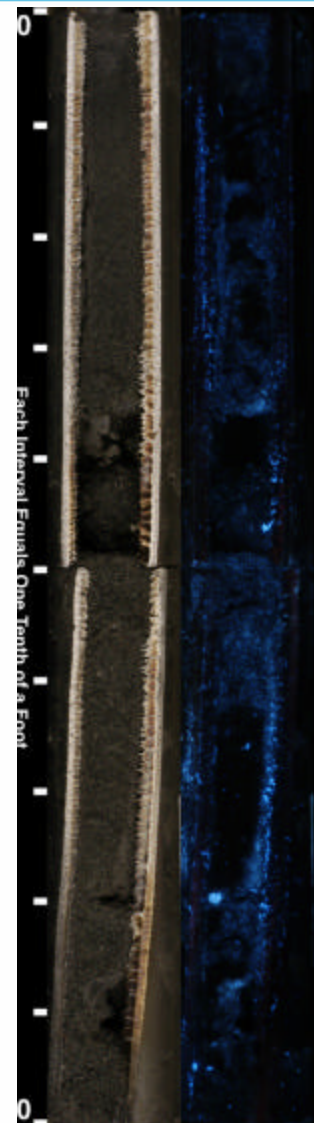
Analytical Results (mg/kg)	
TPHd	150
TPHg	46
